**G0096.03-113-11-R0**  
**ACOUSTICAL PERFORMANCE TEST REPORT**  
**ASTM E 90 AND ASTM E 492**

**Series/Model: Urban Luxury Vinyl 9553 Gold Line Vinyl Plank Flooring**

**Specimen Type: 152 mm (6") Concrete Slab with Drop Ceiling**

**STC     63**  
**IIC     70**

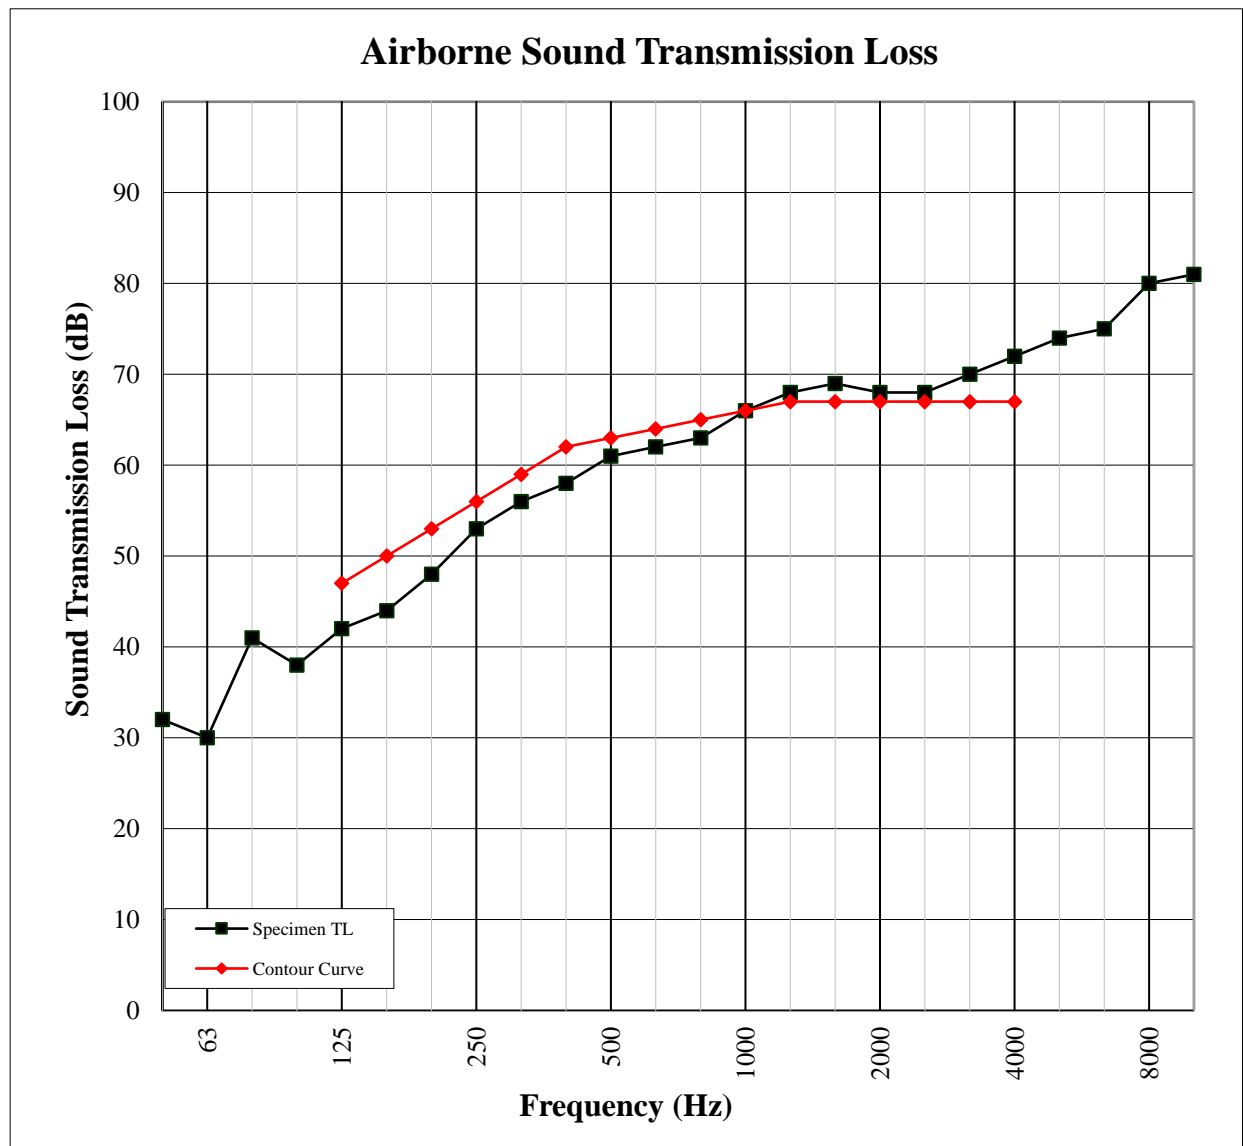
**AIRBORNE SOUND TRANSMISSION LOSS**  
ASTM E 90

**STC Rating**      **63**      (*Sound Transmission Class*)

<b>Test Date</b>	06/24/16
<b>Data File No.</b>	G0096.03
<b>Client</b>	Veneklassen Associates
<b>Description</b>	8 mm (0.31") Urban Luxury Vinyl 9553 Gold Line Vinyl Plank Flooring, 152.4 mm (6") Concrete Slab, 43 mm (1.69") Armstrong HD8906 Drywall Main Beam, 37.3 mm (1.47") Armstrong XL8945P Cross Tee, 88.9 mm (3.5") Johns Manville Kraft Faced R-13 Fiberglass Insulation, 15.9 mm (0.63") National Gypsum Gold Bond® Fire-Shield® Type X Gypsum Panel
<b>Specimen Area</b>	10.98 m <sup>2</sup>
<b>Technician</b>	Daniel B. Mohler

Freq (Hz)	Background SPL (dB)	Absorption (m <sup>2</sup> )	Source SPL (dB)	Receive SPL (dB)	Specimen TL (dB)	95% Confidence Limit	Number of Deficiencies
50	39.4	28.5	99	64	32	4.00	-
63	37.8	38.0	99	64	30	4.50	-
80	39.6	16.4	107	66	41	4.60	-
100	30.5	13.0	105	67	38	1.80	-
125	31.5	10.7	105	64	42	1.60	5
160	28.4	9.3	106	64	44	1.70	6
200	22.6	11.4	103	56	48	1.30	5
250	21.8	11.2	103	51	53	1.10	3
315	22.9	11.0	104	50	56	1.00	3
400	19.6	9.9	103	47	58	0.70	4
500	21.1	9.2	103	44	61	0.50	2
630	23.1	8.9	105	45	62	0.70	2
800	20.8	8.9	104	43	63	0.70	2
1000	17.3	8.8	103	40	66	0.50	0
1250	13.0	8.6	104	38	68	0.80	0
1600	9.0	8.4	104	37	69	0.60	0
2000	6.0	9.5	104	37	68	0.60	0
2500	5.1	10.1	102	35	68	0.50	0
3150	4.6	10.8	103	33	70	0.60	0
4000	4.8	12.2	104	31	72	0.60	0
5000	5.3	13.9	103	28	74	0.60	-
6300	6.1	17.6	97	21	75	0.80	-
8000	6.0	22.4	97	15	80	1.00	-
10000	6.2	27.5	92	8	81	0.50	-

**Deficiencies**      32      (*Sum of Deficiencies*)

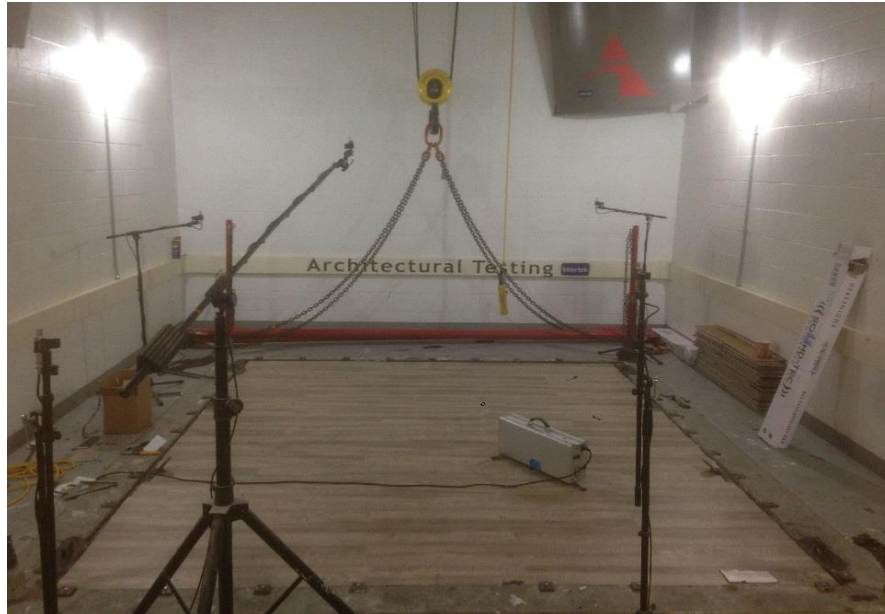
**Source Room View of Test Specimen Installation**

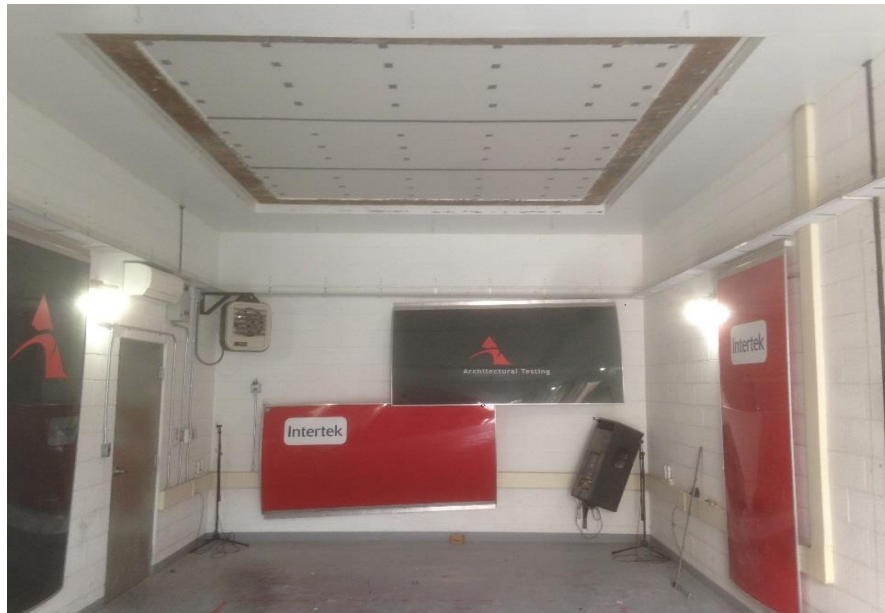
**Receive Room View of Test Specimen Installation**
